**Flood Control Project Maintenance
Levee Inspections**

Fall 2015 Levee Maintenance Deficiency Summary Report

Sacramento River Basin

Marysville Levee Commission

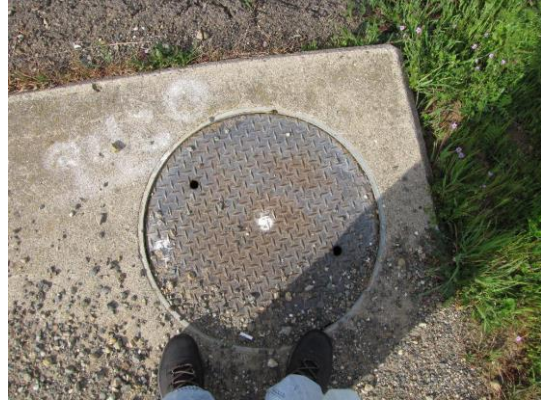
Photo 1 of 3 : UCIP_FA_2015_5156.jpg

Inspector Comments: FS_ID:40931
 DS_ID:19100
 EP_NO: 14518
 FS_HLM: 0.922
 Repair Type: Non-Urgent
 Crossing Status: Indicator Found
 UCIP Comments: Recommend having owner removing tall grass along slopes to properly inspect signs of pipe failure.
 FIELD_STRUCT_DESC: 1 of 2: 10-inch steel pipe through levee, 4.0 feet below crown. Flap gate on waterward end. Concrete vault on waterward shoulder. Metal meter box on the landward shoulder. Pump placed on concrete footings at toe of landward slope. Drainage for underpass. Pipes approx. 2.5-feet apart. (Permit No. 14518-1987).
 FS Date: 03/14/2013

Close up view of manhole.

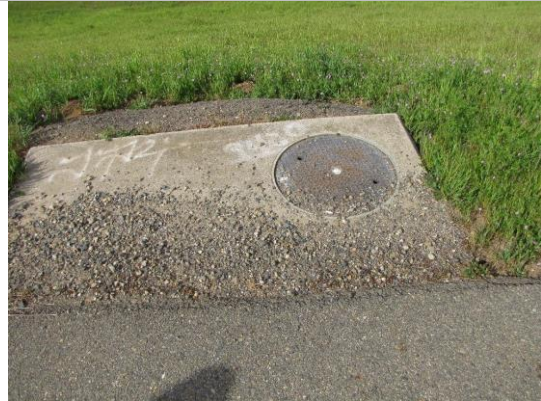
Photo 2 of 3 : UCIP_FA_2015_5157.jpg

Concrete vault on waterward shoulder with manhole.

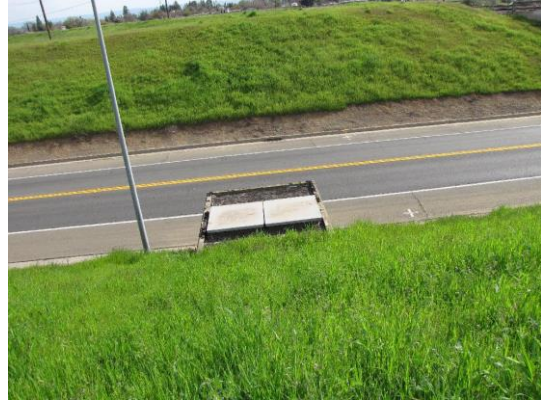
Photo 3 of 3 : UCIP_FA_2015_5158.jpg

LM Start	0.96	Rating **	M	Issue No.	37 (cont)
LM End	0.96	Issue Type +	En	Location *	N/A
Category	Supplemental			GPS Latitude/Longitude	
				Start	End
Item	DWR UCIP Field Study			39.158946 °	39.158946 °
				-121.589930 °	-121.589930 °
DWR ID					
Action/Comments					
Inspector Comments: FS_ID:40931					
DS_ID:19100					
EP_NO: 14518					
FS_HLM: 0.922					
Repair Type: Non-Urgent					
Crossing Status: Indicator Found

View of landward side.

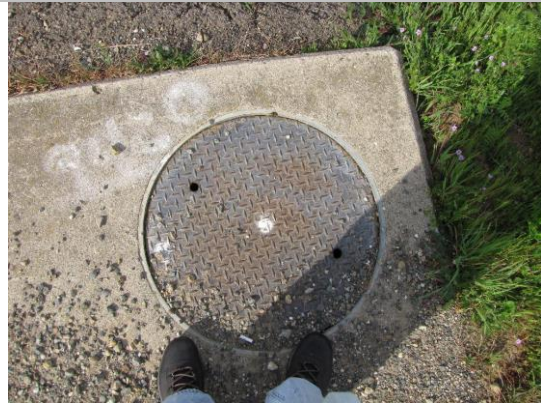
Photo 1 of 3 : UCIP_FA_2015_5159.jpg

LM Start	0.96	Rating **	M	Issue No.	38
LM End	0.96	Issue Type +	En	Location *	N/A
Category	Supplemental			GPS Latitude/Longitude	
				Start	End
Item	DWR UCIP Field Study			39.158951 °	39.158951 °
				-121.589929 °	-121.589929 °
DWR ID					
Action/Comments					
Inspector Comments: FS_ID:40933 DS_ID:19093 EP_NO: 14518 FS_HLM: 0.923 Repair Type: Non-Urgent Crossing Status: Indicator Found UCIP Comments: Recommend having owner removing tall grass along slopes to properly inspect signs of pipe failure. FIELD_STRUCT_DESC: 2 of 2: 10-inch steel pipe through levee, 4.0 feet below crown. Flap gate on waterward end. Concrete vault on waterward shoulder. Metal meter box on the landward shoulder. Pump placed on concrete footings at toe of landward slope. Drainage for underpass. Pipes approx. 2.5-feet apart. (Permit No. 14518-1987). FS Date: 03/14/2013

Close up of manhole.

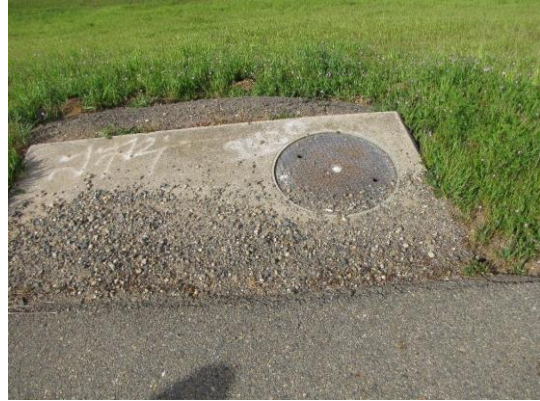
Photo 2 of 3 : UCIP_FA_2015_5160.jpg

Inspector Comments: FS_ID:40933
 DS_ID:19093
 EP_NO: 14518
 FS_HLM: 0.923
 Repair Type: Non-Urgent
 Crossing Status: Indicator Found
 UCIP Comments: Recommend having owner removing tall grass along slopes to properly inspect signs of pipe failure.
 FIELD_STRUCT_DESC: 2 of 2: 10-inch steel pipe through levee, 4.0 feet below crown. Flap gate on waterward end. Concrete vault on waterward shoulder. Metal meter box on the landward shoulder. Pump placed on concrete footings at toe of landward slope. Drainage for underpass. Pipes approx. 2.5-feet apart. (Permit No. 14518-1987).
 FS Date: 03/14/2013

Concrete vault located on waterward shoulder.

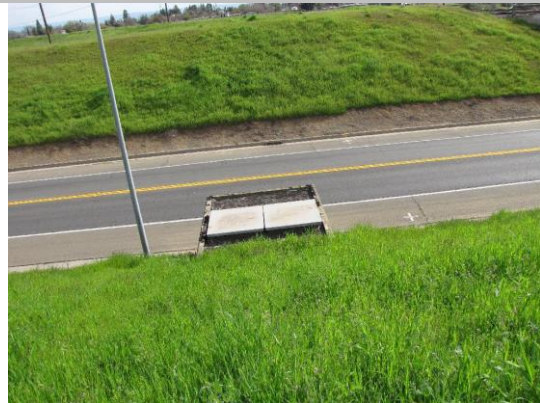
Photo 3 of 3 : UCIP_FA_2015_5161.jpg

View of pump concrete building located on landward side.

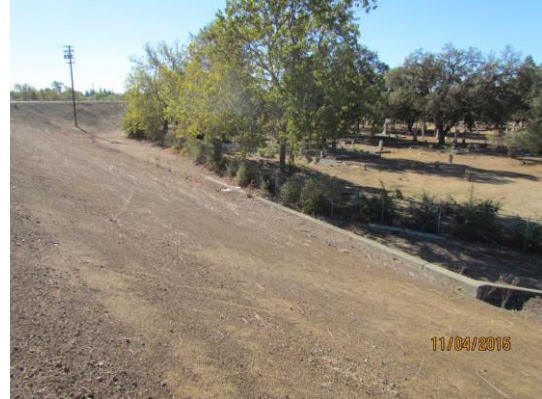
Photo 1 of 1 : FA_2015_NA0004_104_36_20151112_00002.jpg

LM Start	0.97	Rating **	M	Issue No.	36
LM End	0.97	Issue Type +	Ob	Location *	WS
Category	Earthen Levee			GPS Latitude/Longitude	
				Start	End
Item	Encroachments			39.159210 °	39.159210 °
				-121.590033 °	-121.590033 °
DWR ID	DWR_NA0004_01_f _ 2013_36				
Action/Comments					
Retaining Wall					
Inspector Comments: Concrete retaining wall and toe cut noted by the Corp.

View of the concrete retaining wall at the toe of the levee on the waterward side looking downstream. Fall 2015.

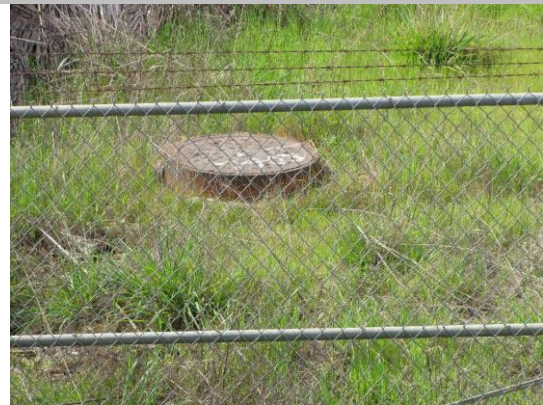
Photo 1 of 3 : UCIP_FA_2015_5162.jpg

Action/Comments					
Inspector Comments: FS_ID:40935 DS_ID:19115 EP_NO: 12878 FS_HLM: 3.2027 Repair Type: Non-Urgent Crossing Status: Indicator Found UCIP Comments: Need to contact owner to determine additional information about crossing and alignment. FIELD_STRUCT_DESC: 24-inch steel pipe encasing 4-inch PVC communications extension through the levee, annular gap grouted, 8 feet below levee crown. Cutoff wall (12x12x20-inch) around extension from levee slopes. (Permit No. 12878-1980). FS Date: 03/14/2013

Manhole located behind fenced area on landward side.

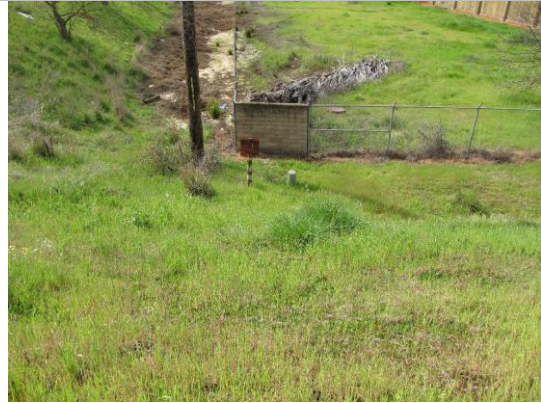
Photo 2 of 3 : UCIP_FA_2015_5163.jpg

Inspector Comments: FS_ID:40935
 DS_ID:19115
 EP_NO: 12878
 FS_HLM: 3.2027
 Repair Type: Non-Urgent
 Crossing Status: Indicator Found
 UCIP Comments: Need to contact owner to determine additional information about crossing and alignment.
 FIELD_STRUCT_DESC: 24-inch steel pipe encasing 4-inch PVC communications extension through the levee, annular gap grouted, 8 feet below levee crown. Cutoff wall (12x12x20-inch) around extension from levee slopes. (Permit No. 12878-1980).
 FS Date: 03/14/2013

View of landward side.

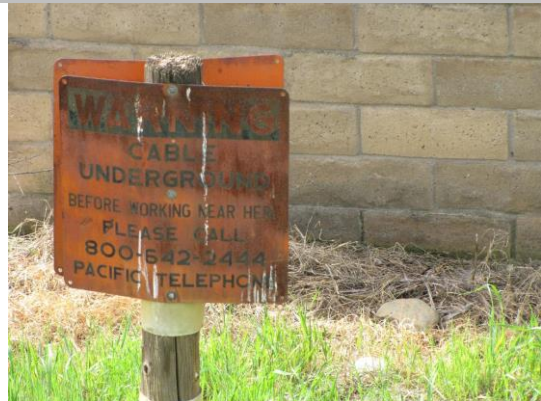
Photo 3 of 3 : UCIP_FA_2015_5164.jpg

Marker on landward side.

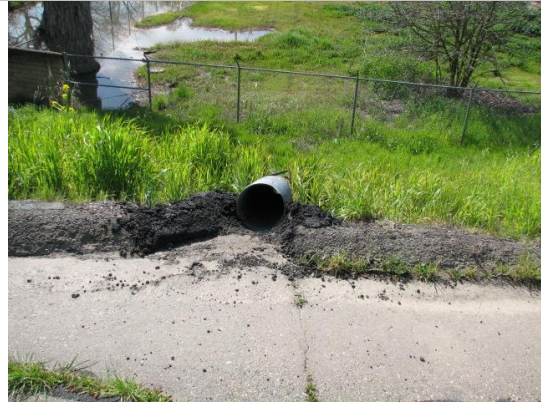
Photo 1 of 1 : FA_2015_NA0004_104_1_20151030_00001.jpg

LM Start	3.23	Rating **	M	Issue No.	1
LM End	3.23	Issue Type +	Ma	Location *	LS
Category	Earthen Levee			GPS Latitude/Longitude	
				Start	End
Item	Slope Stability			39.163590 °	39.163590 °
				-121.559495 °	-121.559495 °
DWR ID	DWR_NA0004_01_s _ 2012_1				
Action/Comments					
Repair slope instability. Inspector Comments: This drain pipe has been added to the site on the Corps PI.

This site is on the Corps PI.

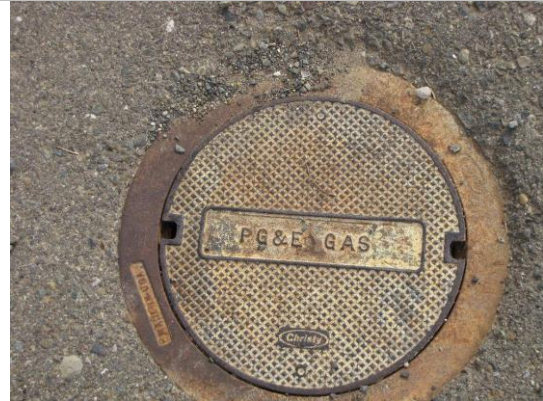
Photo 1 of 3 : UCIP_FA_2015_5165.jpg

Inspector Comments: FS_ID:40936
 DS_ID:19117
 EP_NO: 3684
 FS_HLM: 0.0103
 Repair Type: Non-Urgent
 Crossing Status: Indicator Found
 UCIP Comments: Marker missing on landward side. Need to contact owner to determine status of crossing. Need date of last inspection and confirmation that crossing is still in operable condition.
 FIELD_STRUCT_DESC: 8-inch gas line through the levee, 4.0 feet below the crown. Concrete cutoff wall around pipe, near center of levee (8x56x56-inch). Gas main cut off 110-feet landward of waterward toe. Permit covers replacement of portion of pre-existing gas main and cutoff wall (Permit No. 3684-1961).
 FS Date: 03/15/2013

PG&E Gas service hole located on levee crown.

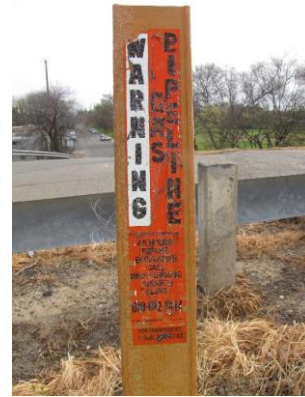
Photo 2 of 3 : UCIP_FA_2015_5166.jpg

Pipeliem marker with contact information located on waterward shoulder.

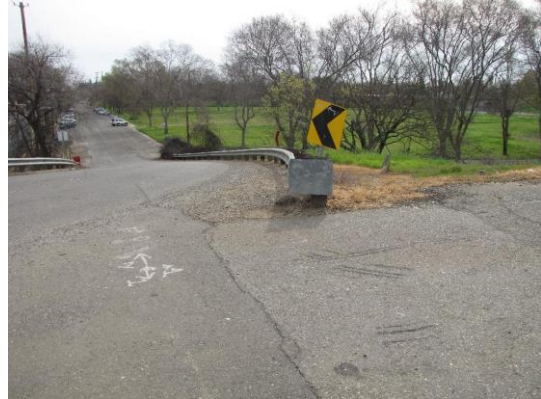
Photo 3 of 3 : UCIP_FA_2015_5167.jpg

LM Start	0.00	Rating **	M	Issue No.	10 (cont)
LM End	0.00	Issue Type +	En	Location *	WS
Category	Supplemental			GPS Latitude/Longitude	
				Start	End
Item	DWR UCIP Field Study			39.149548 °	39.149548 °
				-121.601110 °	-121.601110 °
DWR ID					
Action/Comments					
Inspector Comments: FS_ID:40936					
DS_ID:19117					
EP_NO: 3684					
FS_HLM: 0.0103					
Repair Type: Non-Urgent					
Crossing Status: Indicator Found

View of landward side.

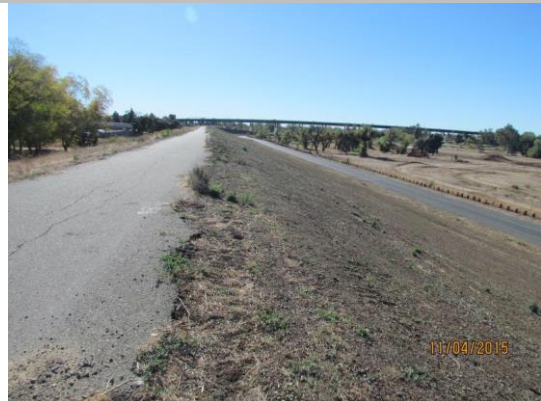
Photo 1 of 1 : FA_2015_NA0004_105_5_20151112_00002.jpg

LM Start	0.01	Rating **	A	Issue No.	5
LM End	1.23	Issue Type +	Ma	Location *	WS
Category	Earthen Levee			GPS Latitude/Longitude	
				Start	End
Item	Vegetation			39.149387 °	39.134750 °
				-121.601125 °	-121.594045 °
DWR ID	DWR_NA0004_02_f_2015_5				
Action/Comments					
Control annual grass and weeds on the levee slopes and easements. Inspector Comments: Levee slope has been burned and dragged.

View of the vegetation on the waterward side of the levee looking downstream. Fall 2015.

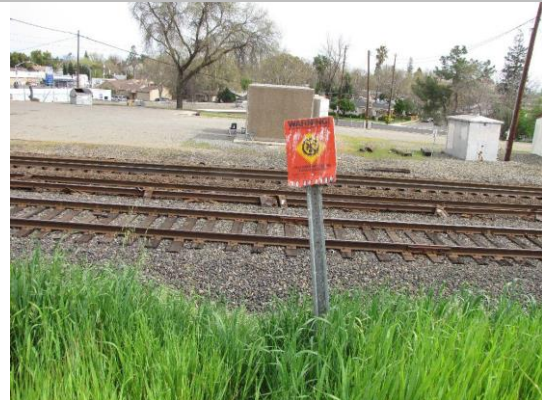
Photo 1 of 3 : UCIP_FA_2015_4381.jpg

Action/Comments					
Inspector Comments: FS_ID:40940 DS_ID:19123 EP_NO: N/A FS_HLM: 0.891 Repair Type: Non-Urgent Crossing Status: Indicator Found UCIP Comments: Unable to tell if crossing goes through levee; according to Frank Miller crossing does not cross levee. Need to contact owner to confirm alignment. FIELD_STRUCT_DESC: Fiber optics communication line through levee. Marker on waterward shoulder. FS Date: 03/15/2013

View of landward side with bldg that could be associated with cable line.

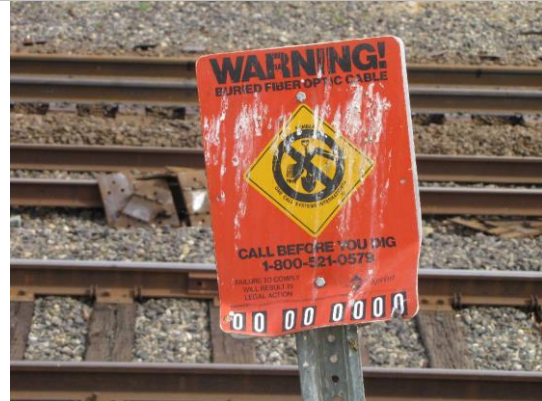
Photo 2 of 3 : UCIP_FA_2015_4382.jpg

Inspector Comments: FS_ID:40940
 DS_ID:19123
 EP_NO: N/A
 FS_HLM: 0.891
 Repair Type: Non-Urgent
 Crossing Status: Indicator Found
 UCIP Comments: Unable to tell if crossing goes through levee; according to Frank Miller crossing does not cross levee. Need to contact owner to confirm alignment.
 FIELD_STRUCT_DESC: Fiber optics communication line through levee. Marker on waterward shoulder.
 FS Date: 03/15/2013

Buried fiber optical cable marker with contact information located on landward shoulder.

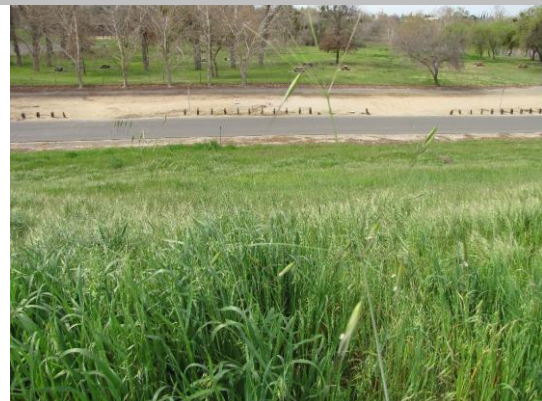
Photo 3 of 3 : UCIP_FA_2015_4383.jpg

View of waterward slope.

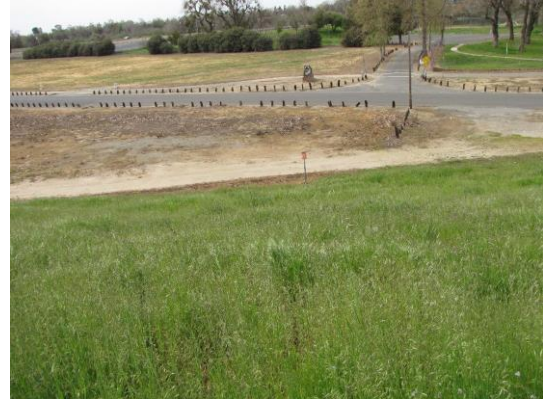
Photo 1 of 3 : UCIP_FA_2015_4384.jpg

LM Start	0.91	Rating **	M	Issue No.	13
LM End	0.91	Issue Type +	En	Location *	WS
Category	Supplemental			GPS Latitude/Longitude	
				Start	End
Item	DWR UCIP Field Study			39.137749 °	39.137749 °
				-121.598560 °	-121.598560 °
DWR ID					
Action/Comments					
Inspector Comments: FS_ID:38272					
DS_ID:19104					
EP_NO: N/A					
FS_HLM: 0.934					
Repair Type: Non-Urgent					
Crossing Status: Indicator Found

View of markers located on waterward toe.

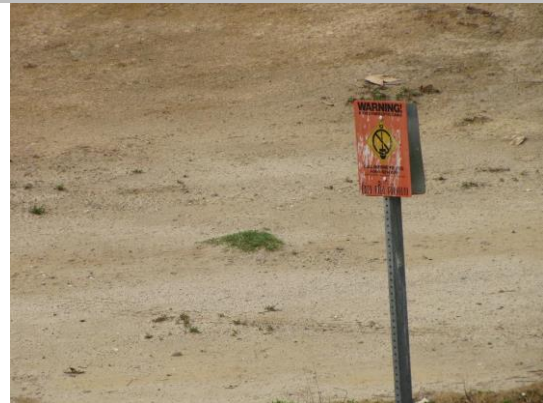
Photo 2 of 3 : UCIP_FA_2015_4385.jpg

View of markers located on waterward toe.

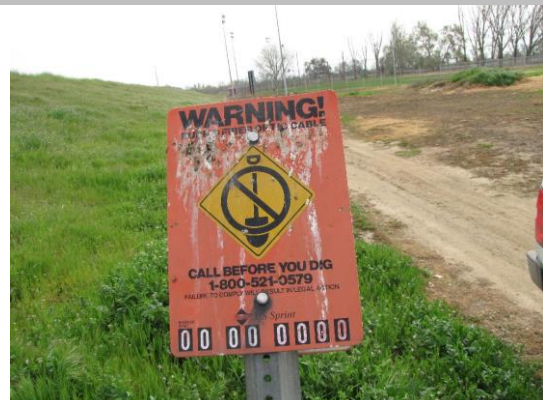
Photo 3 of 3 : UCIP_FA_2015_6461.jpg

Close up of markers located at toe of waterward side.

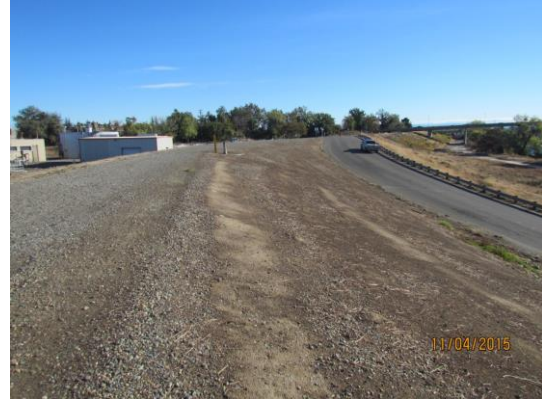
Photo 1 of 1 : FA_2015_NA0004_106_25_20151112_00007.jpg

LM Start	0.01	Rating **	A	Issue No.	25
LM End	0.27	Issue Type +	Ma	Location *	WS
Category	Earthen Levee			GPS Latitude/Longitude	
				Start	End
Item	Vegetation			39.134850 °	39.135147 °
				-121.593650 °	-121.588987 °
DWR ID	DWR_NA0004_03_f _ 2015_25				
Action/Comments					
Control annual grass and weeds on the levee slopes and easements. Inspector Comments: LMA has burned and dragged the levee.

View of the vegetation on the waterward side of the levee looking upstream. Fall 2015.

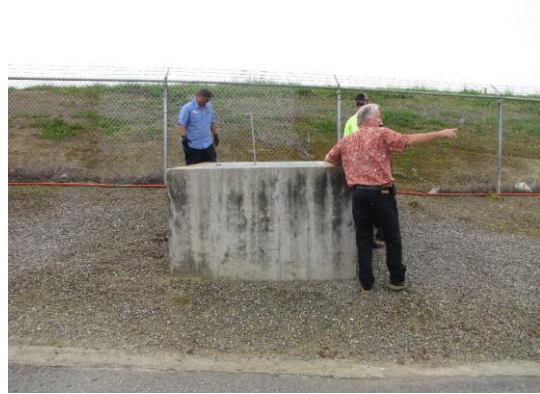
Photo 1 of 2 : UCIP_FA_2015_6345.jpg

Inspector Comments: FS_ID:41024
 DS_ID:25055
 EP_NO: N/A
 FS_HLM: 0.04
 Repair Type: Non-Urgent
 Crossing Status: Found
 UCIP Comments: Appears that crossing is currently not in use. If crossing is to be abandoned, owner will need to contact CVFPB to coordinate about proper removal.
 FIELD_STRUCT_DESC: 10-inch sewer line visible on landward side. According to Marysville Treatment Plant Manager this crossing was installed in 1995-1996. Coordinates for box located on landward side: 39.135185, -121.593254. Note coordinates used for levee crossing are projected coordinates.
 FS Date: 03/14/2013

View of concrete box located on landward side--crossing not in use according to Marysville Sewage Treatment Plant Manager.

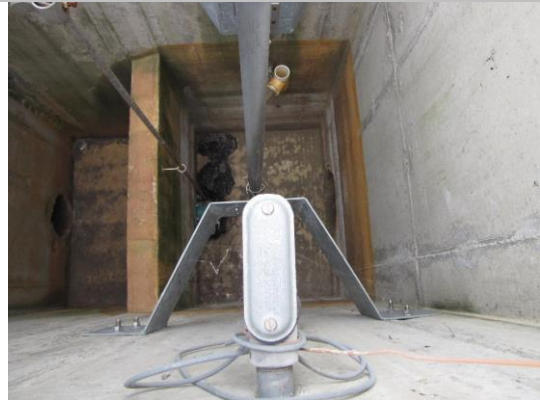
Photo 2 of 2 : UCIP_FA_2015_6346.jpg

Inside view of concrete box.

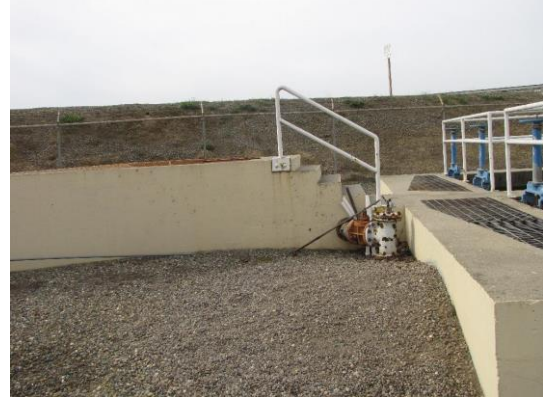
Photo 1 of 3 : UCIP_FA_2015_6462.jpg

LM Start	0.07	Rating **	M	Issue No.	36
LM End	0.07	Issue Type +	En	Location *	LS
Category	Supplemental			GPS Latitude/Longitude	
				Start	End
Item	DWR UCIP Field Study			39.135090 °	39.135090 °
				-121.592663 °	-121.592663 °
DWR ID					
Action/Comments					
Inspector Comments: FS_ID:41025 DS_ID:19126 EP_NO: N/A FS_HLM: 0.07 Repair Type: Non-Urgent Crossing Status: Found

View of levee slope on waterward.

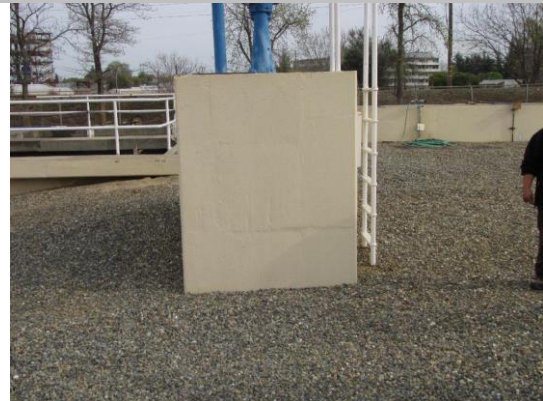
Photo 2 of 3 : UCIP_FA_2015_6463.jpg

Standpipe where old line is still located.

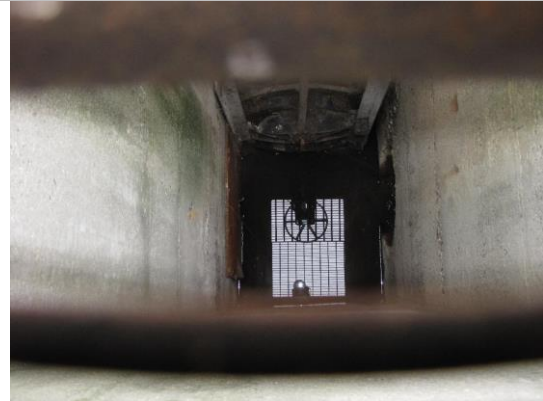
Photo 3 of 3 : UCIP_FA_2015_6464.jpg

LM Start	0.07	Rating **	M	Issue No.	36 (cont)
LM End	0.07	Issue Type +	En	Location *	LS
Category	Supplemental			GPS Latitude/Longitude	
				Start	End
Item	DWR UCIP Field Study			39.135090 °	39.135090 °
				-121.592663 °	-121.592663 °
DWR ID					
Action/Comments					
Inspector Comments: FS_ID:41025 DS_ID:19126 EP_NO: N/A FS_HLM: 0.07 Repair Type: Non-Urgent Crossing Status: Found

Abandoned line sealed with metal plate.

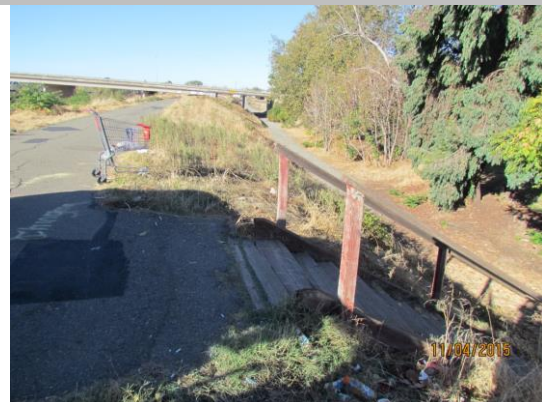
Photo 1 of 1 : FA_2015_NA0004_106_27_20151112_00008.jpg

View of the set of stairs on the landward side of the levee looking downstream. Fall 2015.

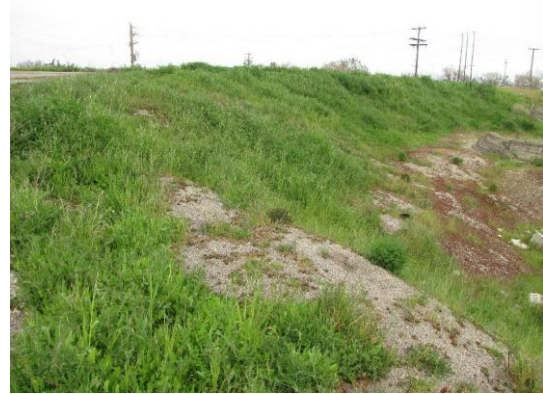
Photo 1 of 2 : UCIP_FA_2015_6347.jpg

View of waterward slope--unable to confirm if crossing is active--line buried.

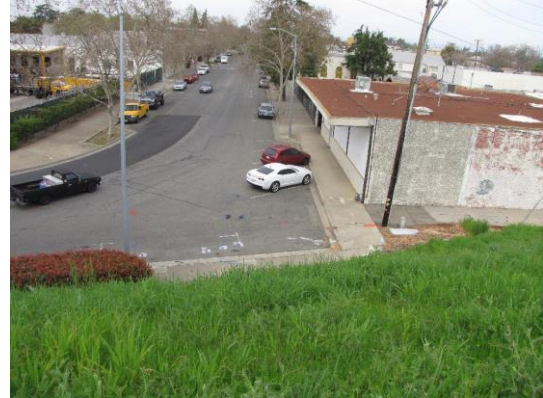
Photo 2 of 2 : UCIP_FA_2015_6391.jpg

Underground service alert (USA) blue paint indicators of water line present on landward side.

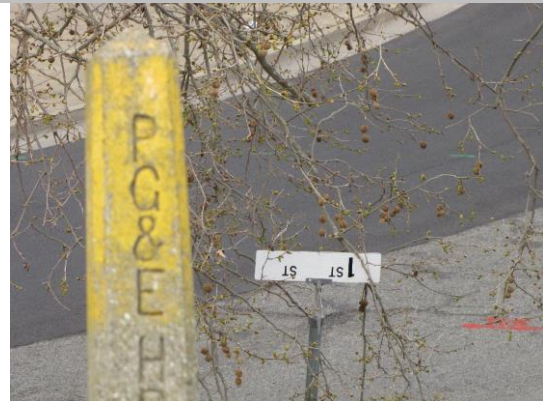
Photo 2 of 3 : UCIP_FA_2015_6393.jpg

PG&E gas line

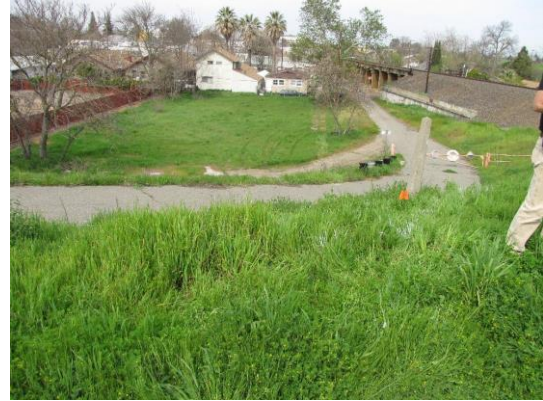
Photo 2 of 2 : UCIP_FA_2015_5994.jpg

View of landward side--underground alert service (USA) flags visible on landward shoulder.

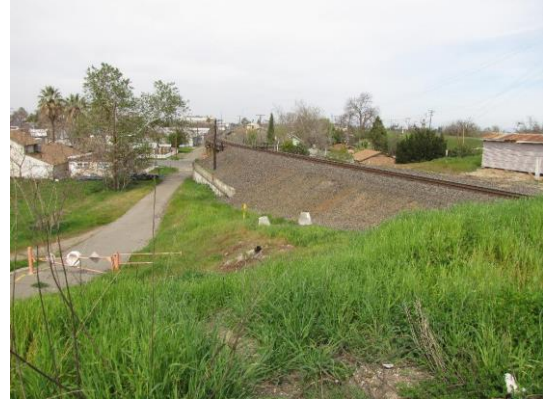
Photo 1 of 3 : UCIP_FA_2015_6395.jpg

Marker visible on landward side.

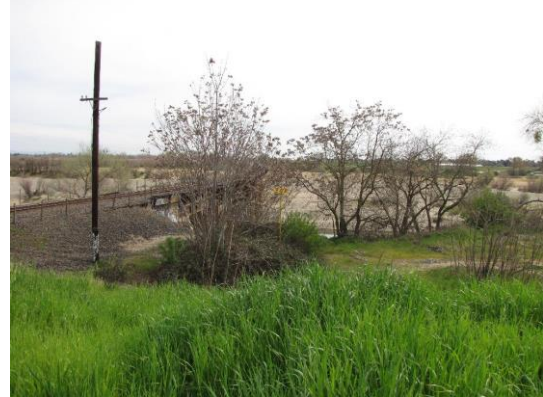
Photo 3 of 3 : UCIP_FA_2015_6397.jpg

View of waterward side--marker visible inside channel.

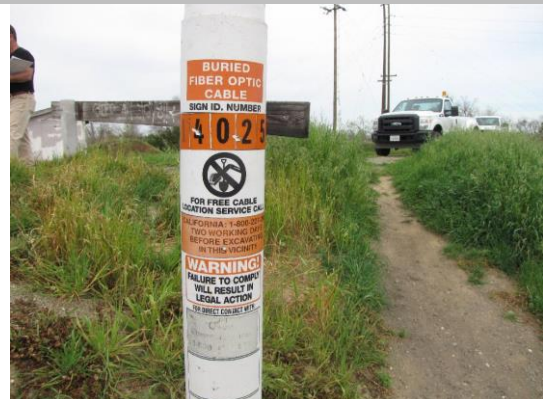
Photo 1 of 3 : UCIP_FA_2015_6398.jpg

Fiber Optic Cable marker visible on landward side.

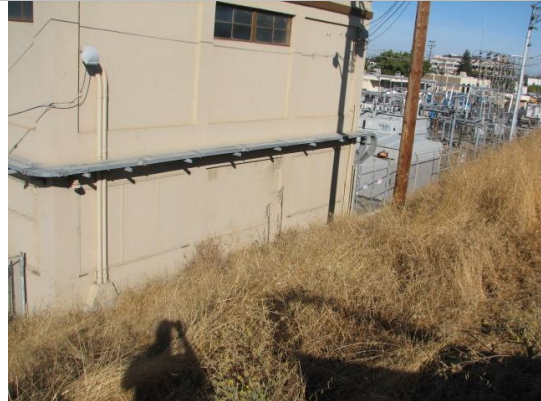
Photo 1 of 1 : FA_2015_NA0004_106_4_20151030_00002.jpg

Building encroaching at landside levee toe.

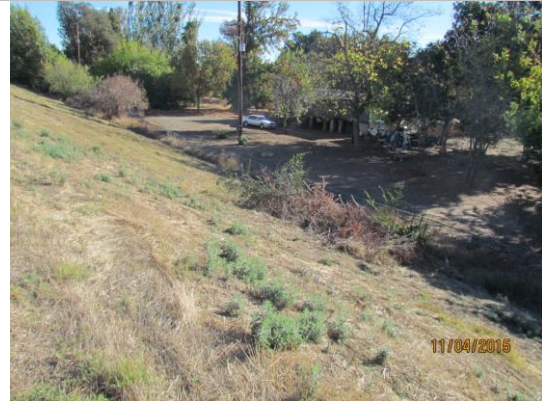
Photo 1 of 1 : FA_2015_NA0004_106_31_20151112_00009.jpg

View of the pile of prunings on the waterward side of the levee looking upstream. Fall 2015.

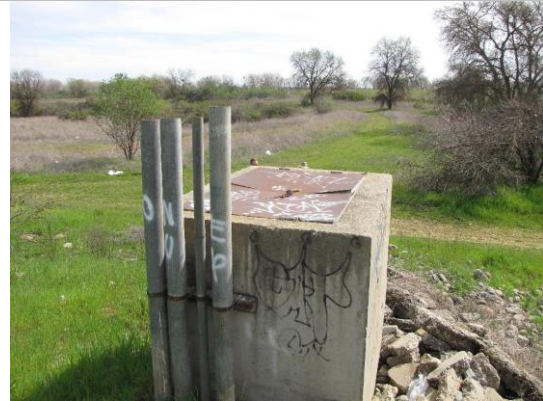
Photo 1 of 3 : UCIP_FA_2015_6501.jpg

Concrete box and vent pipes located on waterward side.

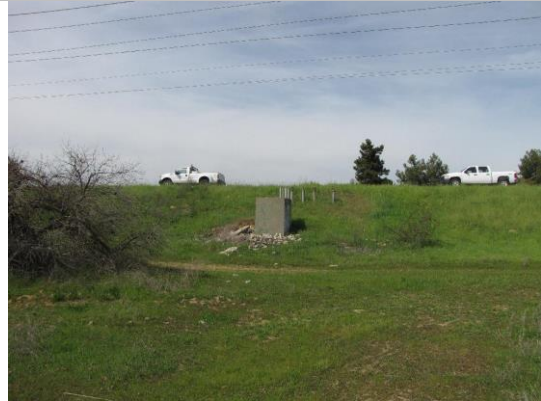
Photo 2 of 3 : UCIP_FA_2015_6502.jpg

View of waterward side--concrete box and vent pipes located on waterward slope.

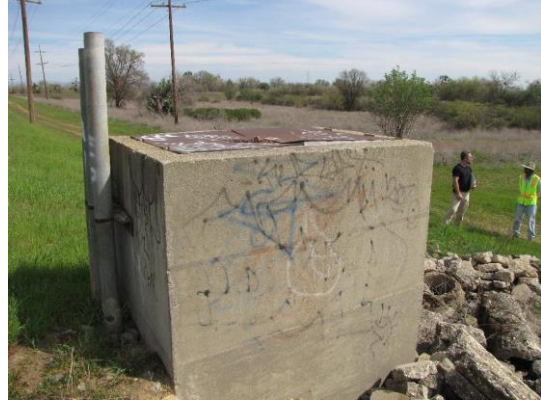
Photo 1 of 3 : UCIP_FA_2015_6576.jpg

Concrete box located on waterward slope.

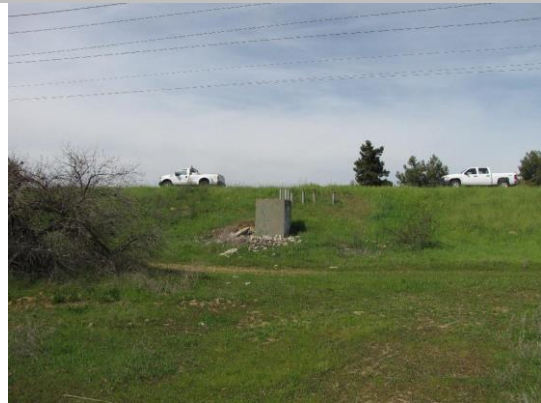
Photo 2 of 3 : UCIP_FA_2015_6577.jpg

Concrete box and vent pipes located on waterward slope.

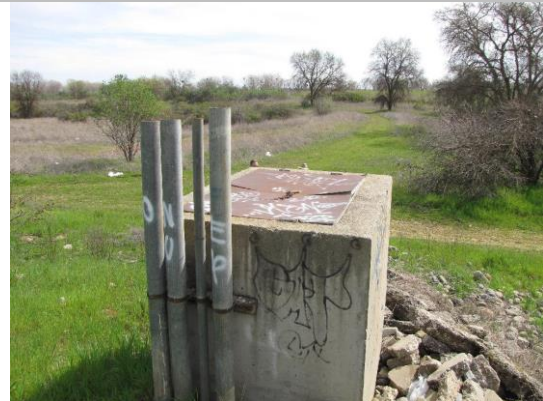
Photo 1 of 3 : UCIP_FA_2015_6579.jpg

Concrete stand pipe located on waterward shoulder.

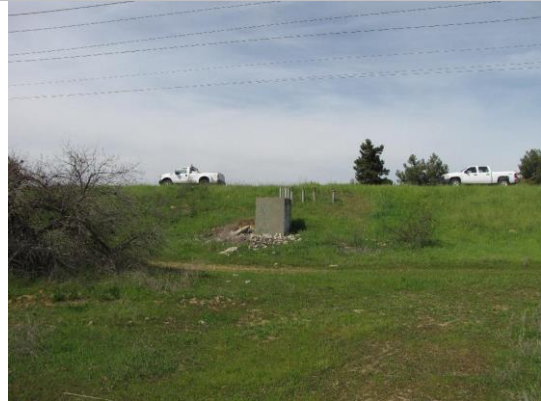
Photo 1 of 3 : UCIP_FA_2015_6498.jpg

View of waterward side--concrete distribution box and gate stems located on waterward slope.

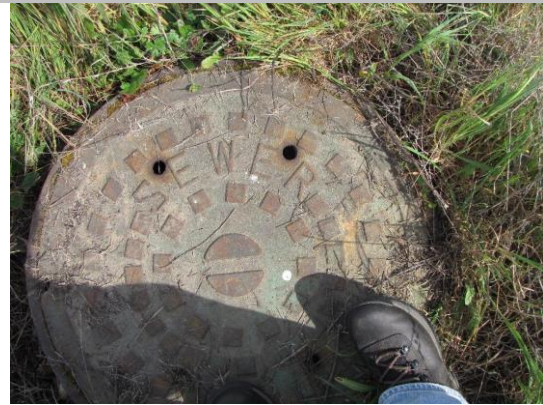
Photo 2 of 2 : UCIP_FA_2015_1288.jpg

Manhole located on landward toe.

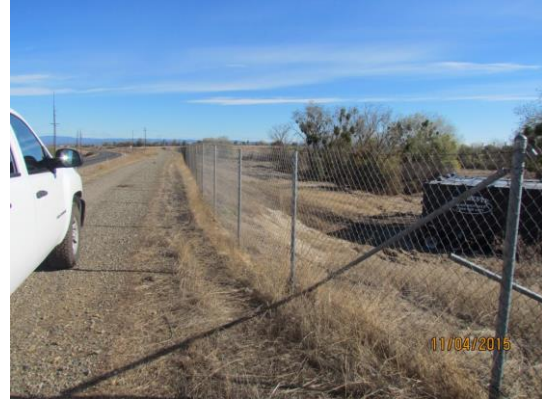
Photo 1 of 1 : FA_2015_NA0004_106_28_20151112_00010.jpg

View of the fence on the waterward shoulder of the levee looking upstream. Fall 2015.

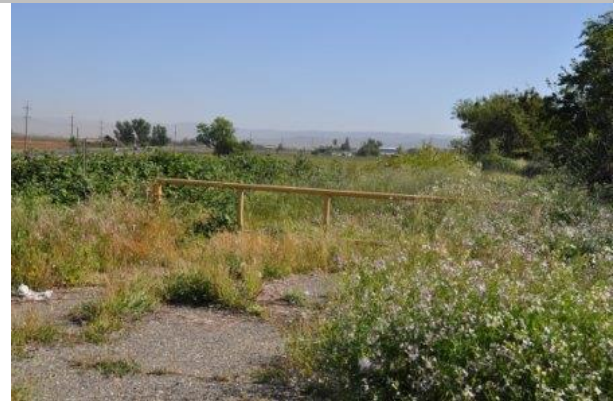
Photo 1 of 1 : FA_2015_NA0004_106_1_20151030_00001.jpg

Marysville, Unit 3 - Spring 2013 - Patrol road vegetation.

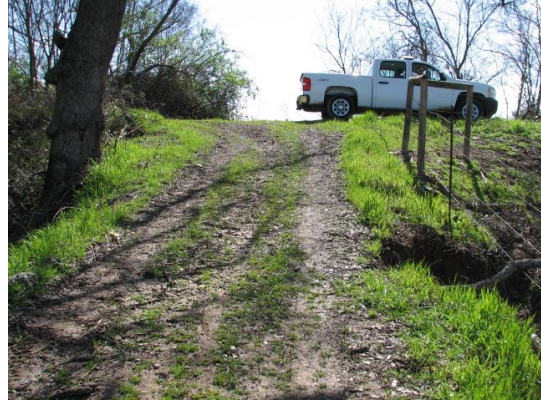
Photo 1 of 1 : FA_2015_NA0004_106_10_20151030_00005.jpg

This ramp is on the patrol road, no known permit.
